**THE COMPARATIVE PHYSICAL
HANDLING QUALITIES OF
RECOVERY INSULATION AND
ROCKWOOL**

**A 1930s SEMI-DETACHED HOUSE IN
SHEFFIELD**

David Firth

January 2004

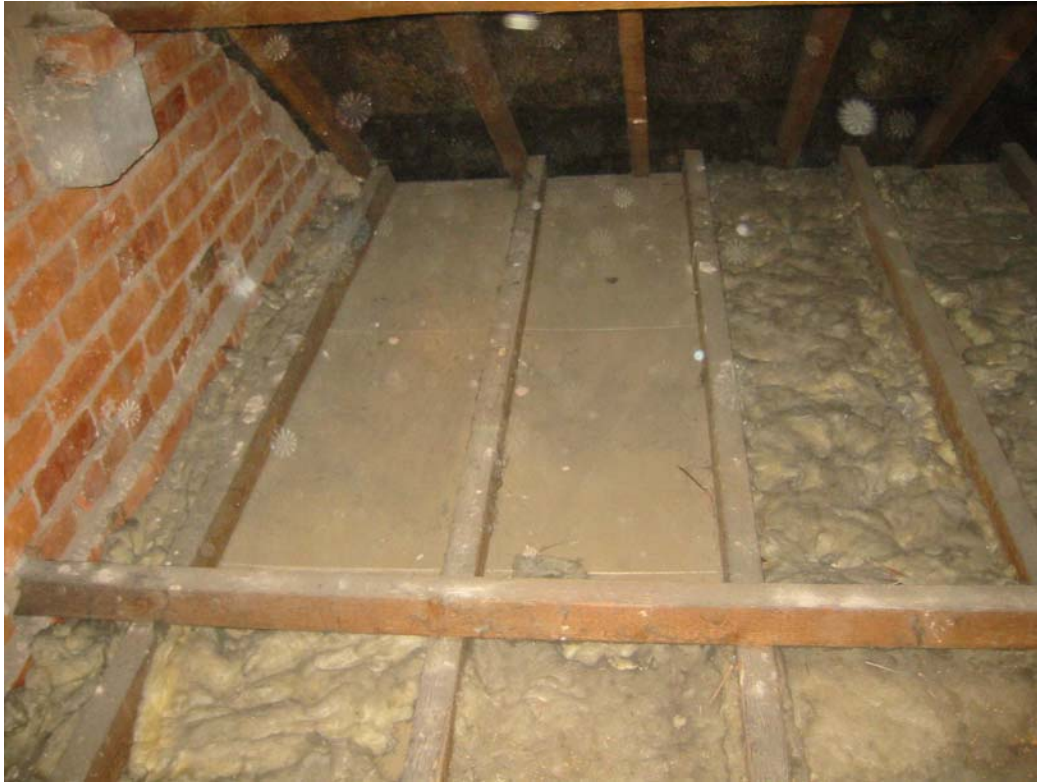
Photo 1. Existing fibreglass insulation was missing to a large area. This was not visible from a head and shoulders inspection of the roof space. Note fibres in air caught by camera flash.

2.1. The installers of the existing fibreglass insulation had not provided enough material to cover the whole area and the part of the roof space that was not visible from a head and shoulders inspection at the loft hatch was not insulated at all. Small gaps between edge joists and walls were not filled and at eaves positions and no care had been taken to fill the edges of the roof.

² Although not readily evident from this study, the fact that there were patches of missing insulation which were out of site of the roof space hatch is evidence of poor workmanship. The author has more than 20 years experience of working in similar houses and this is commonly found. Novice or disreputable insulation installers frequently take short cuts when installing insulation in the knowledge that some home-owners are unlikely, if ever, to look in the roof space. If the cost of paying someone to install the insulation is taken out, and the benefits of knowing the insulation has been installed correctly added in, there is likely to be a very positive overall difference in favour of DIY installations of Recovery Insulation.

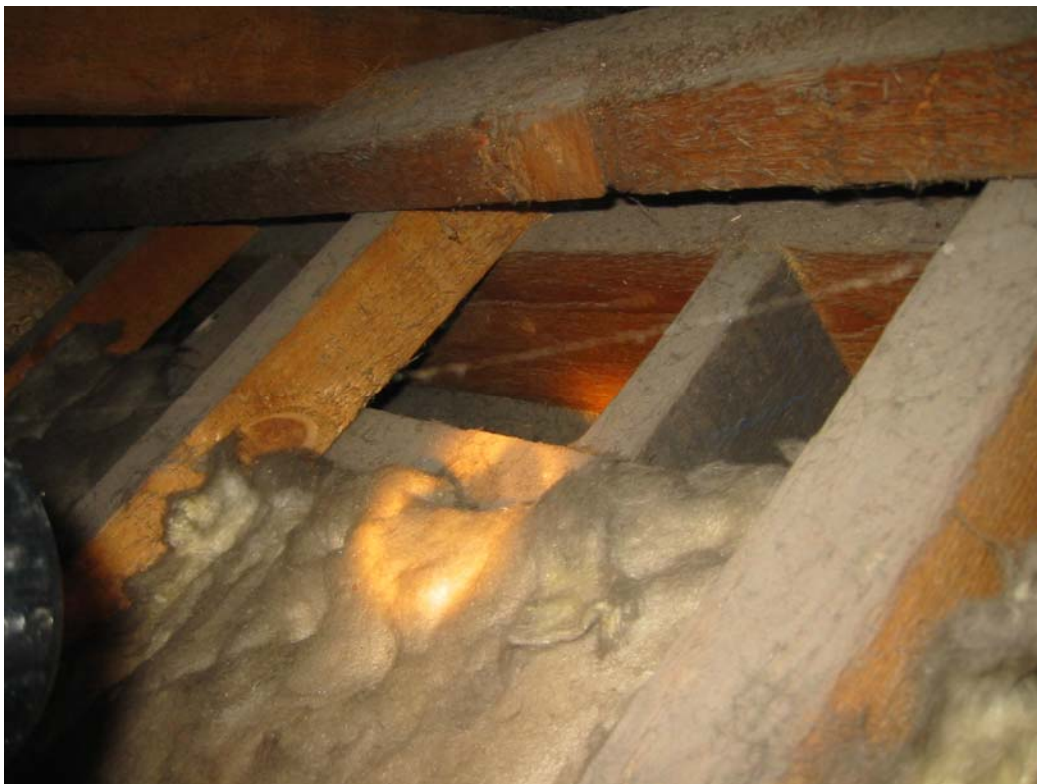
Photo 2. Edges of roof space not insulated.

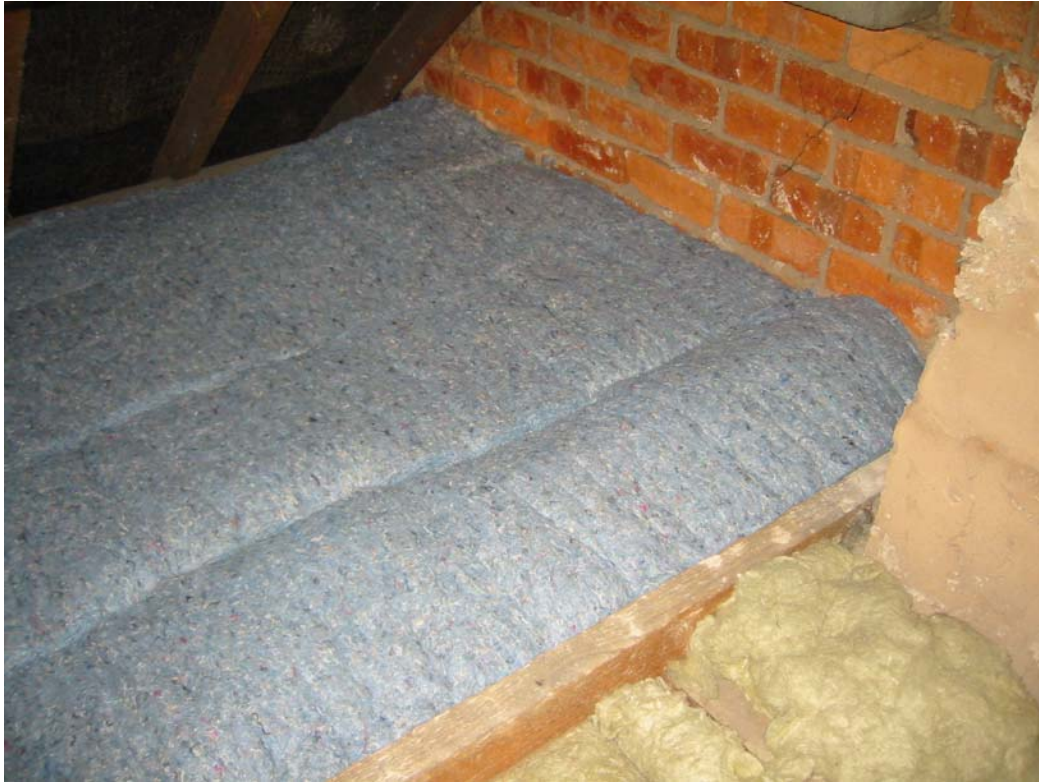
Photo 3. Recovery Insulation laid at right angles to joists above Rockwool.

2.3. The existing fibreglass was laid between the rafters and was left in place. It was decided to lay the Rockwool insulation directly on top of the existing fibreglass insulation and cover the whole roof with one layer of Recovery Insulation laid across the joists at right angles.

- 6.2.1. Installing Recovery Insulation does not require wearing ppe but because fibreglass and Rockwool were present it was necessary to continue to wear mask and overalls.
- 6.2.2. The Recovery Insulation was not as easy to cut as the Rockwool and the Stanley knife blades very quickly became blunt.
- 6.2.3. It was necessary to cut through the insulation completely and could not be torn by hand at all.
- 6.2.4. Where cutting to fit around timbers and into small spaces it was necessary to measure and cut accurately because the material does not easily compress.
- 6.2.5. It was relatively easy to roll out lengths of 3-5m and then pull and tug to adjust to line up with adjacent rolls without tearing. This meant that the installer could make fewer movements in order to adjust the position and fewer movements of temporary boards to stand on.
